TECHNICAL NOTE

Contract NAS8-32982 **Date** 3 August 1982 **Doc.** LMSC-HREC TN D867582

Title RESULTS OF TESTS OF "INSTA-FOAM" THERMAL PROTECTION SYSTEM (TPS) MATERIAL FOR PROTECTION OF EQUIPMENT INSIDE THE SRB AFT SKIRT

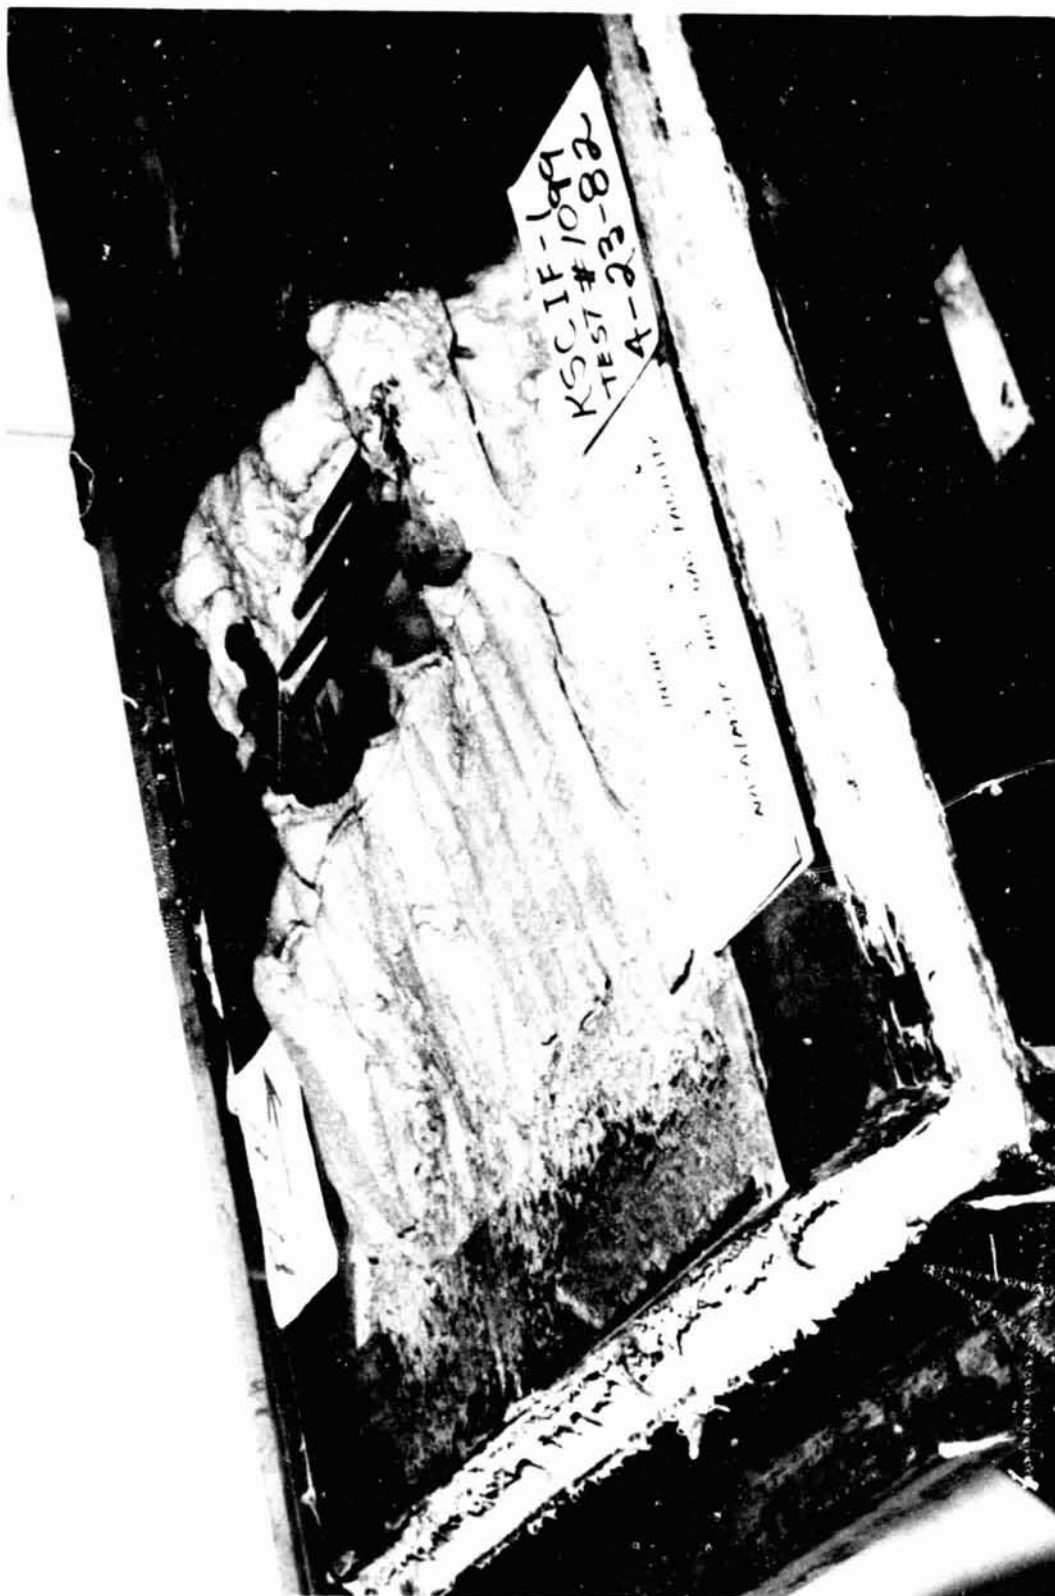
This model was run for 20.06 sec in position 1 of the HGF. The results are shown in Figs. 5 and 6. The foam was almost destroyed, exposing the propellant tubes and burned metal under the foam. Because of these poor results it was decided to reconfigure the test and rerun a similar model at a lower heating rate, because the $32 \text{ Btu/ft}^2\text{-sec}$ was much higher than the value of approximately $12 \text{ Btu/ft}^2\text{-sec}$ measured during flight inside the skirt after curtain failure.

Fig. 5 - Post-Test Photo of Insta-Foam Model No. KSCIF-1

Fig. 6 - Post-Test: Photo of Insta-Foam Model No. KSC-IF-1
